2002 Annual Compliance Report Gunnison, Colorado, Disposal Site

Figure 8-1. 2002 Annual Compliance Drawing for the Gunnison, Colorado, Disposal Site

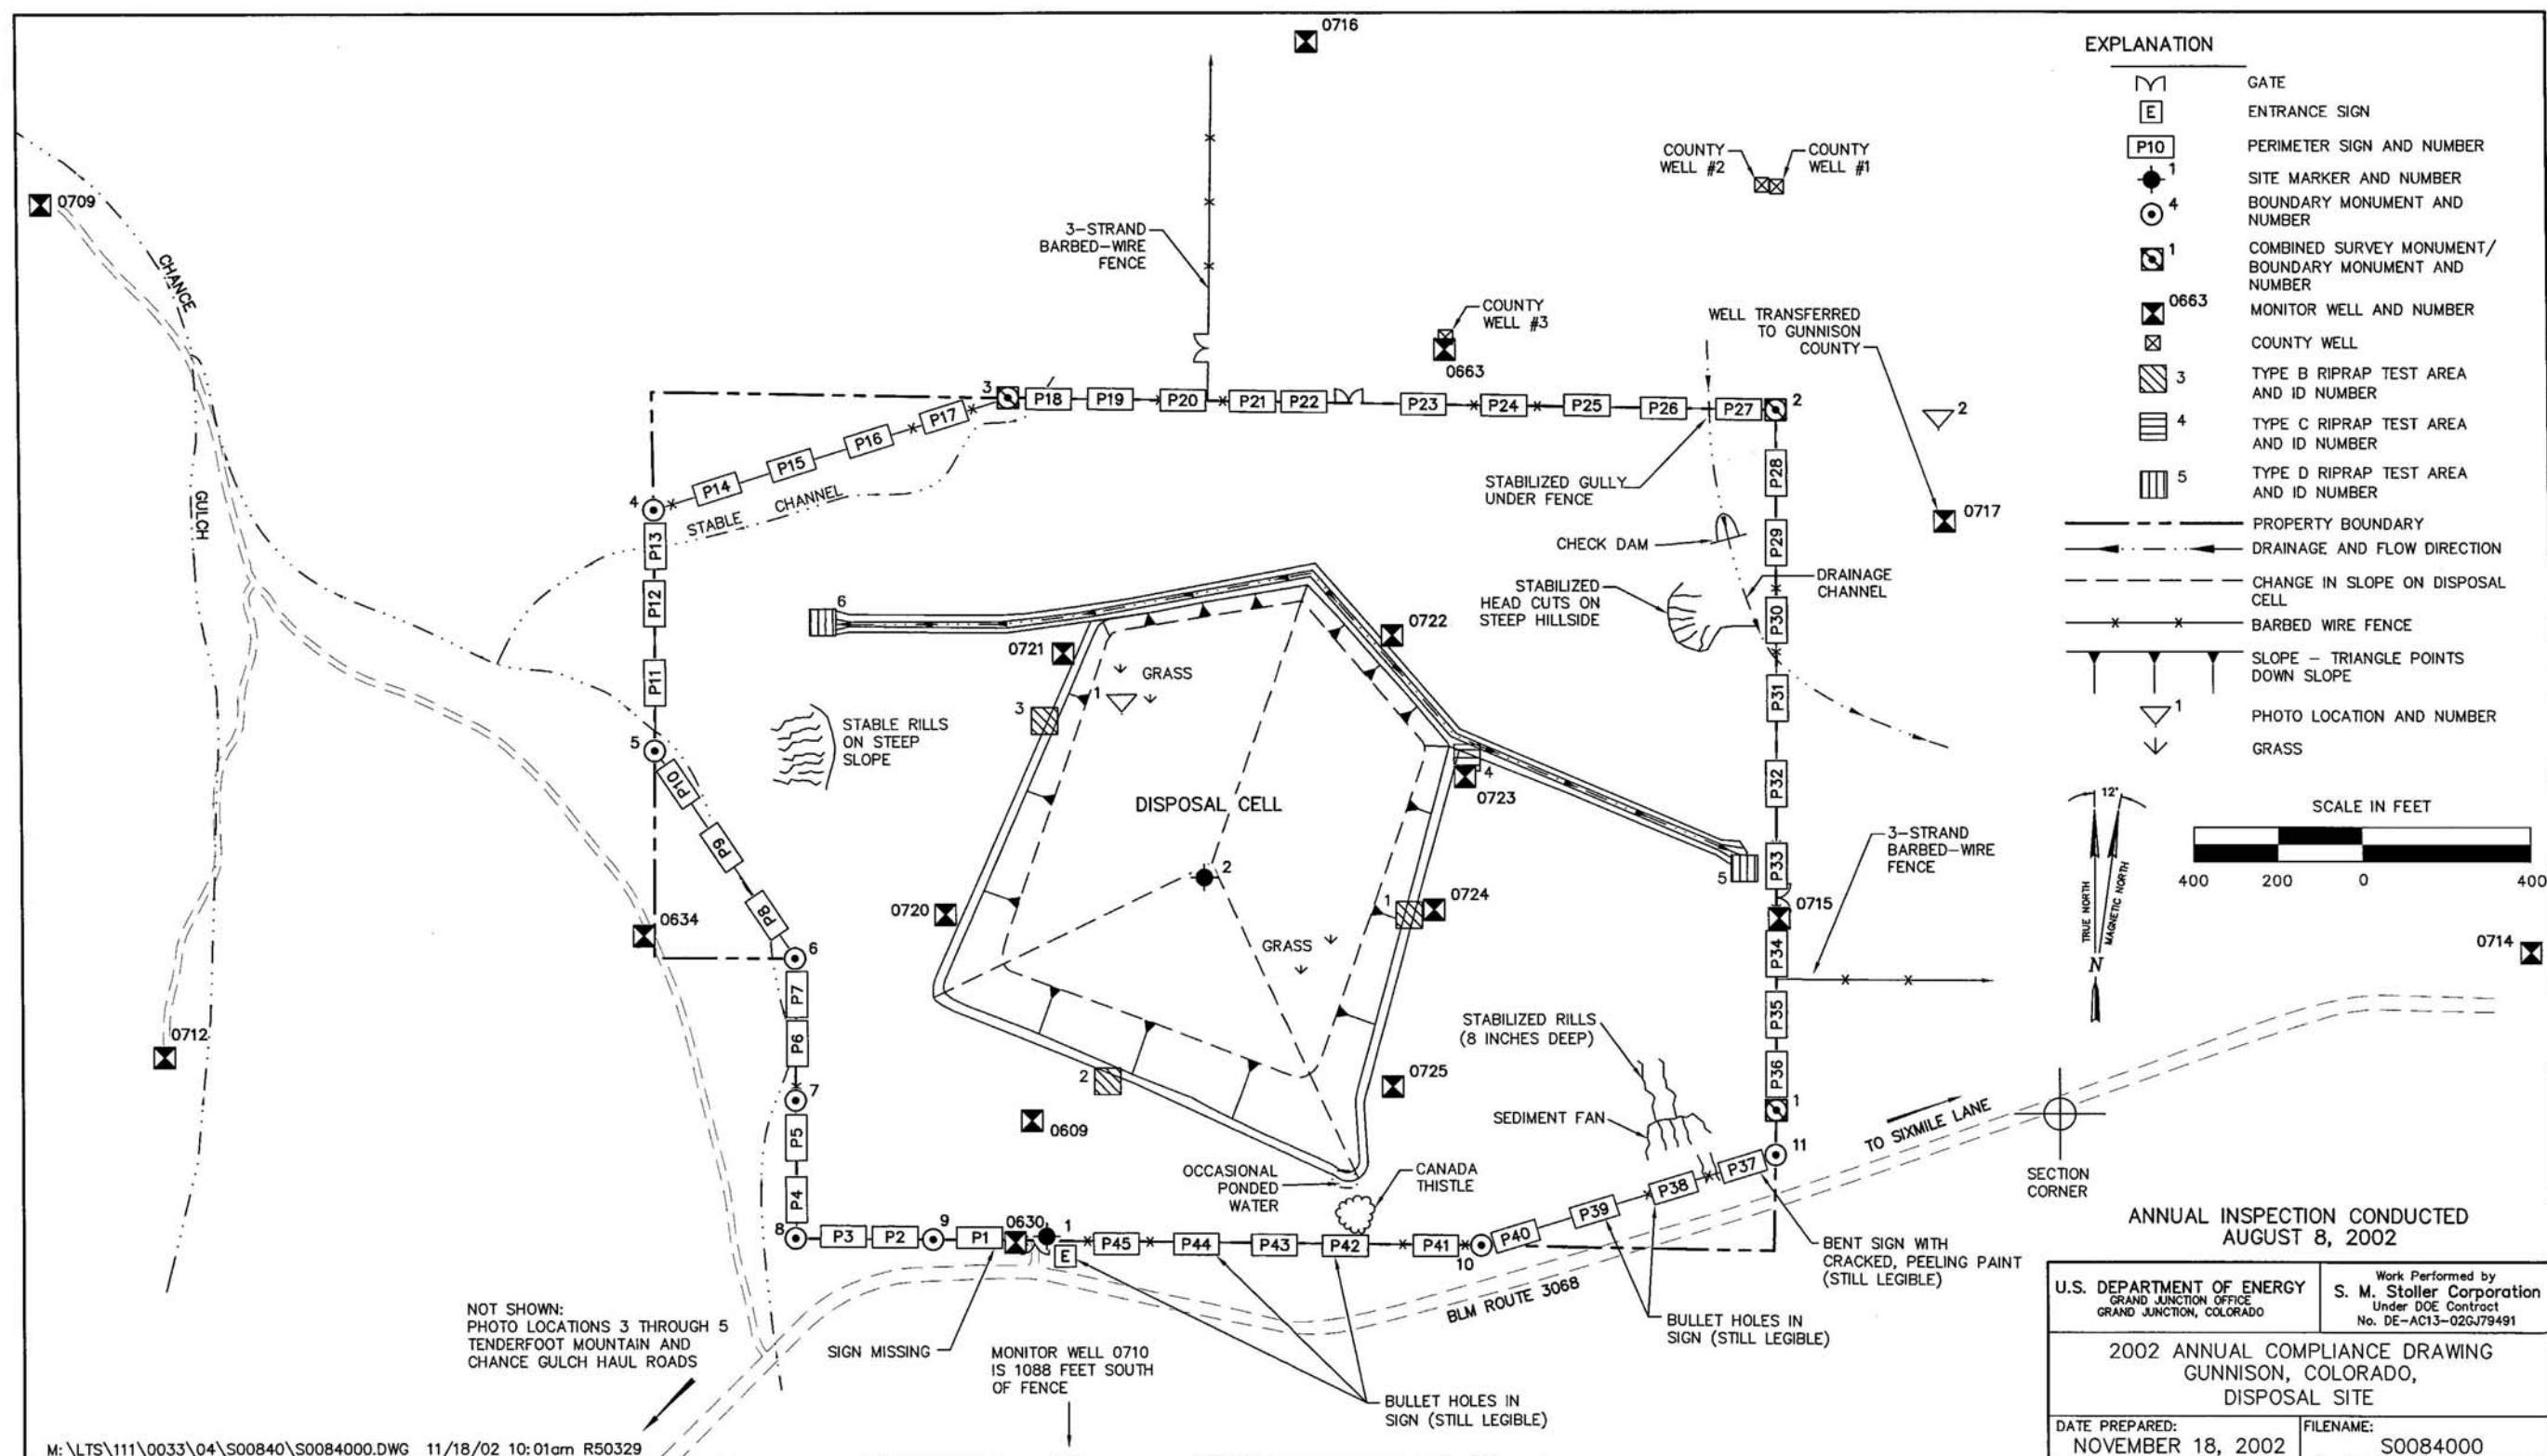
The site, southeast of Gunnison, Colorado, was inspected on August 8, 2002. Results of the inspection are described below. Features and photograph locations (PLs) mentioned in this report are shown on Figure 8-1. Numbers in the left margin of this report refer to items summarized in the Executive Summary table.
